Inspection Report

Property Address:
1111 Somewhere in
Provo UT 84604

Ideal Inspections of America, Inc.

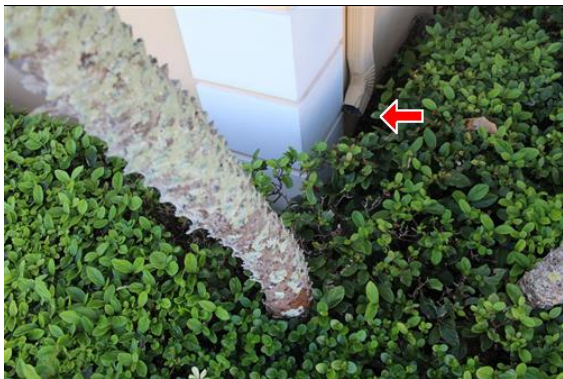
1.3 Item 1(Picture)

1.3 Installation of downspout extension is needed to avoid water erosion around pipe. Covering of pipe and downspout repair is recommended.

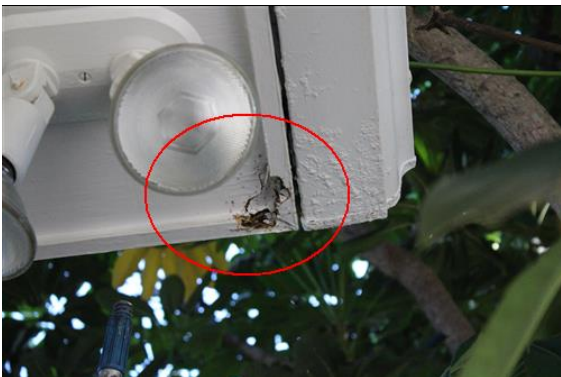
2.6 Item 1(Picture)

2.6 Rotted soffit in north east corner of the house. See attached Termite report. Repair is recommended.

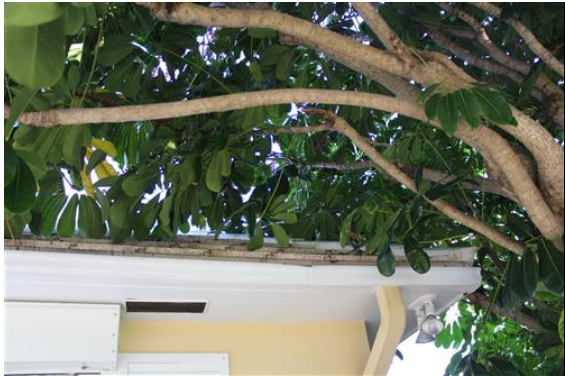
2.7 Item 1(Picture)

2.7 Trimming of trees at least three feet away from roof line is recommended.

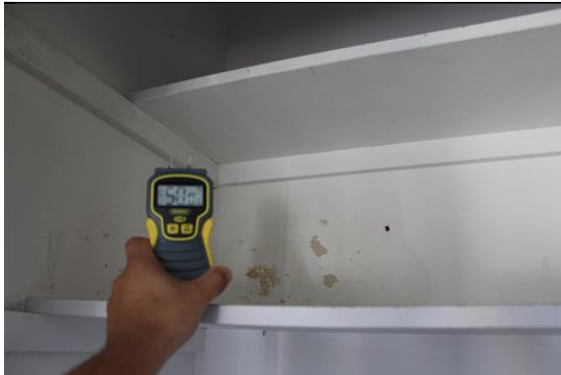
3.1 Item 1(Picture)

3.1 Wet drywall inside garage closet. There is broken tiles on roof in this area. Further Evaluation and repair by a general contractor is recommended.

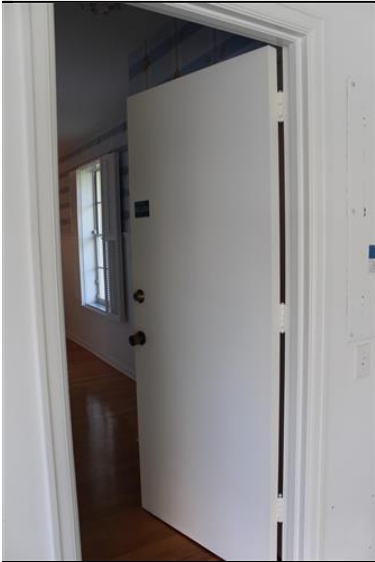
3.5 Item 1(Picture)

3.5 This door should not stay open on its own. Installation of self closing hinges is recommended.

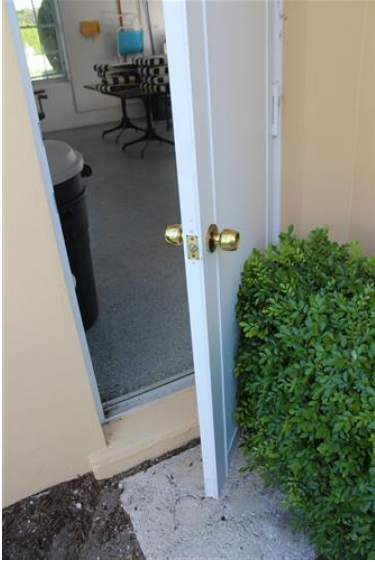
3.6 Item 1(Picture)

3.6 Door can't open properly due to hedges behind it. Trimming of hedges is recommended.

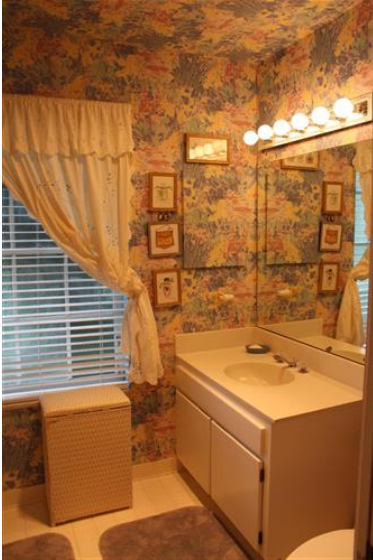
4.1.A Item 1(Picture)

4.1.A Repair of bathroom wall in the north side of the house is recommended. Sealing around diverter valve to prevent water intrusion on the wall is needed.

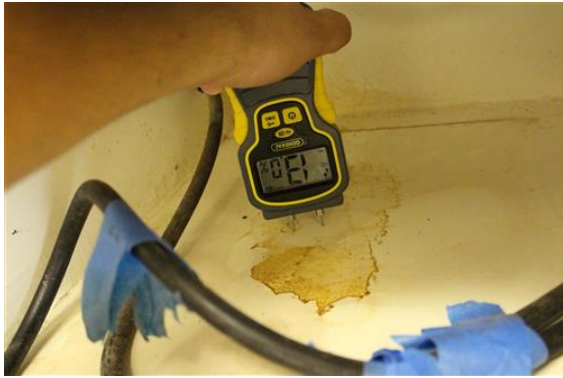
4.6.A Item 1(Picture)

4.6.A Signs of leak on kitchen cabinet. Dry at the time of inspection.

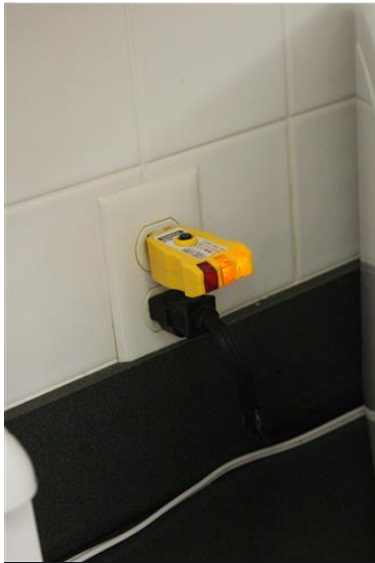
4.7.A Item 1(Picture)

4.7.A Installation is recommended.

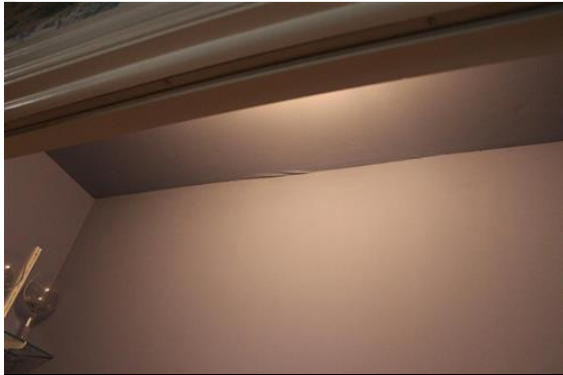
4.0.B Item 1(Picture)

4.0.B Signs of water leak in bar ceiling and around a/c vent.

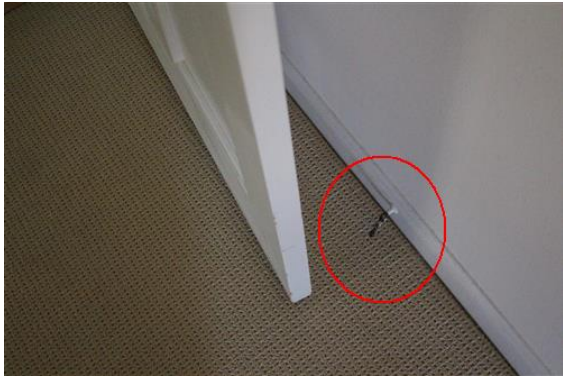
4.1.B Item 1(Picture)

4.1.B Damaged door stopper throughout the home. Repair is recommended.

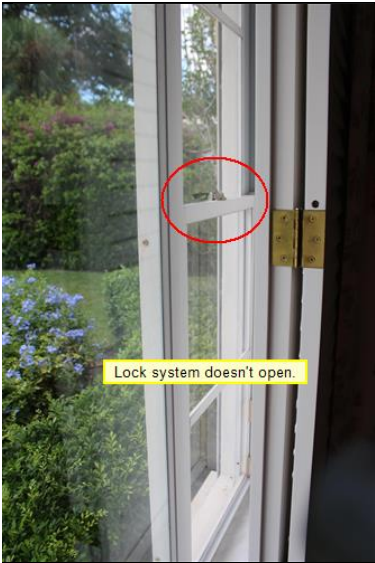
4.4.B Item 1(Picture)

4.4.B Most windows were locked and could not be tested, but many of them have defective lock system and some of them will not stay open. Further evaluation and repair is recommended.

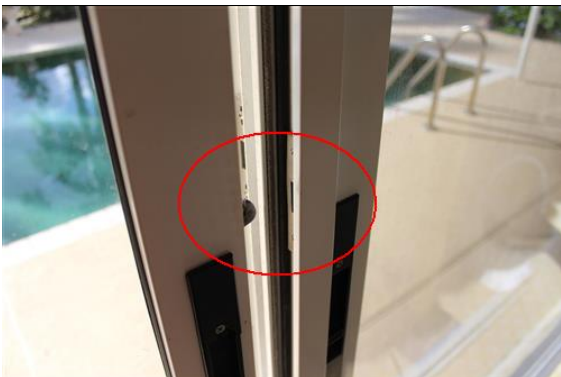
4.5.B Item 1(Picture)

4.5.B Sliding door lock system is not working properly. Repair is recommended.

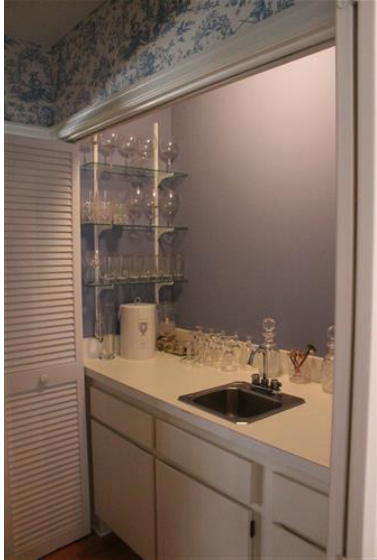
4.6.B Item 1(Picture)

4.6.B Signs of water leak in bar cabinet. Dry at the time of inspection.

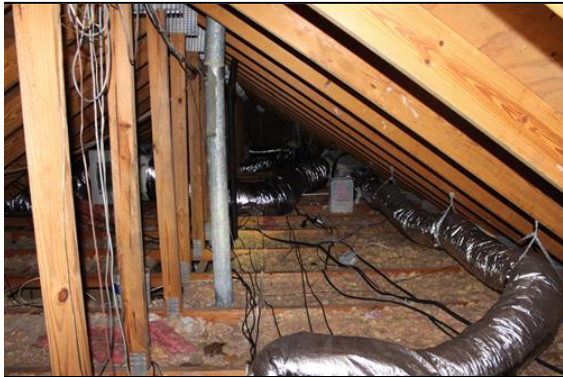
7.0 Item 1(Picture)

7.0 Existing blown insulation has less than 4" thickness. Repair by a licensed contractor is recommended

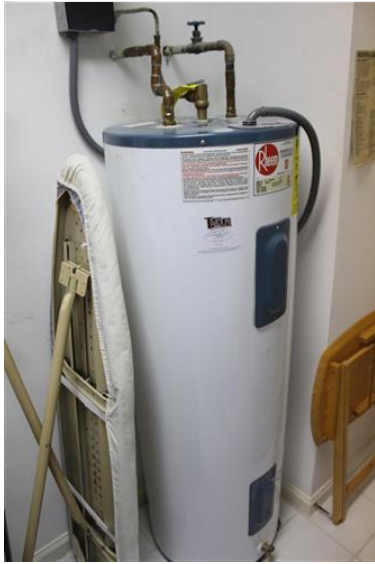
8.2 Item 1(Picture)

8.2 The T&P (Test and Pressure) valve on water heater needs a 3/4 threaded pipe to extend within 6 inches of floor for safety. I recommend repair by a licensed contractor.

This unit is working properly, but is at the end of its life expectancy and could require repair or replacement at anytime within the next five years.

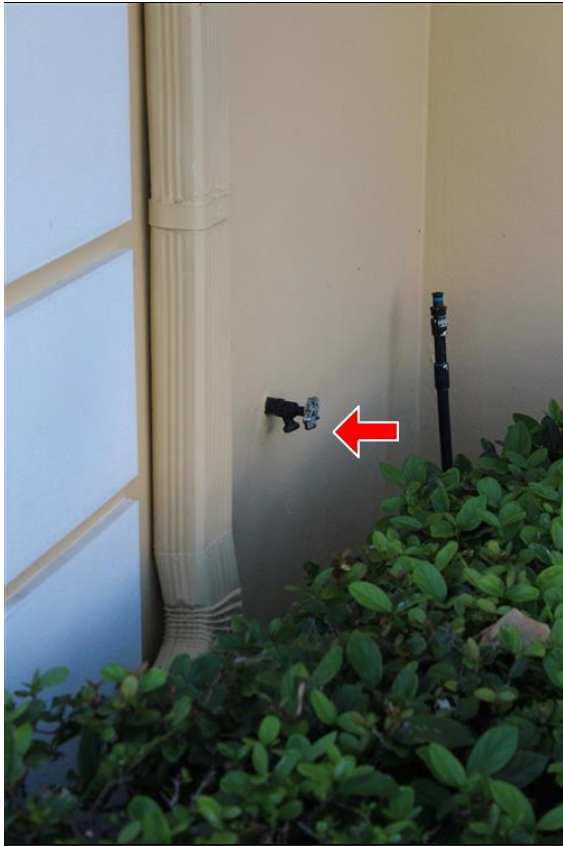
8.4 Item 1(Picture)

8.4 Installation of hose bib anti-siphon valve is recommended. Leaking exterior hose bib. Shower/tub valve is leaking. Further evaluation and repair by a licensed contractor is needed.

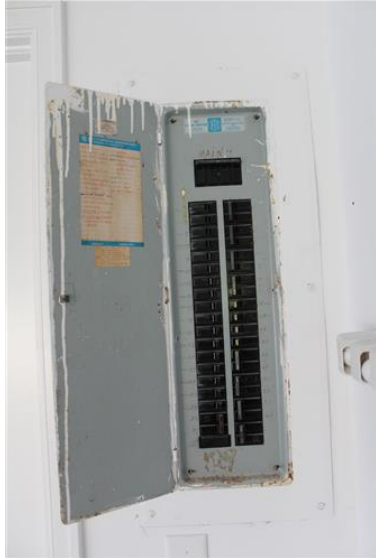
9.1 Item 1(Picture)

9.1 Double wiring present in a main panel circuit. Further revision and repair by a Licensed electrical contractor is recommended.

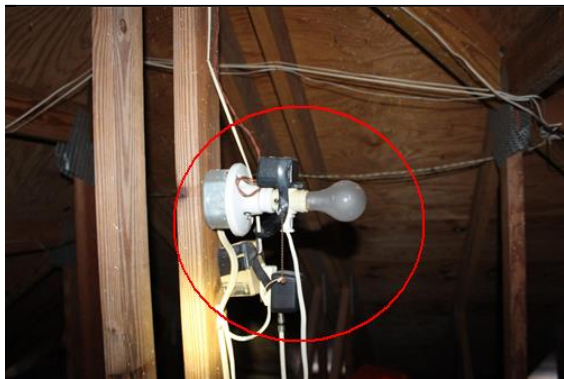
9.3 Item 1(Picture)

9.3 Loud noise coming from transformer in attic. Further evaluation and repair as needed by a licensed contractor is recommended.

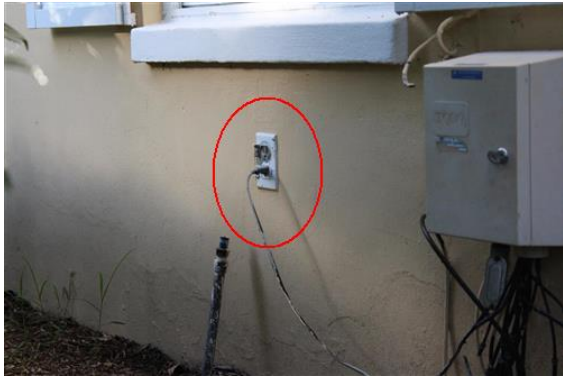
9.4 Item 1(Picture)

9.4 The outside outlet cover is damaged and needs repair or replace.

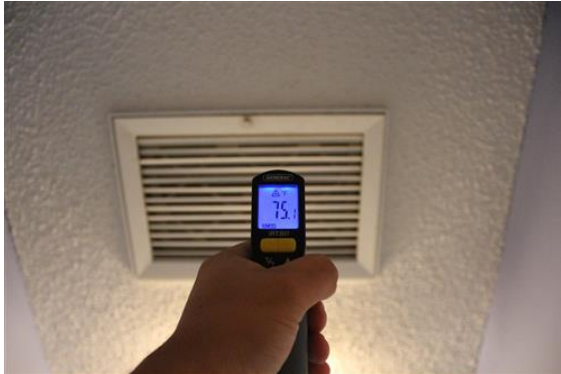
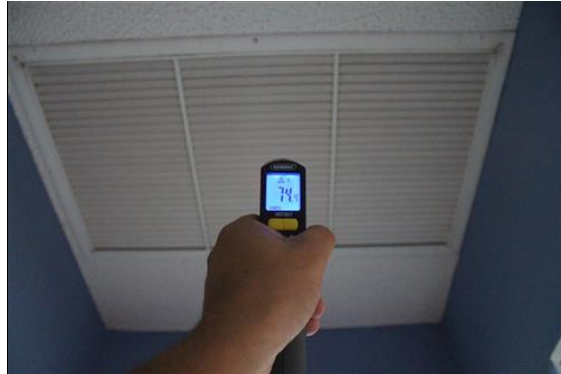
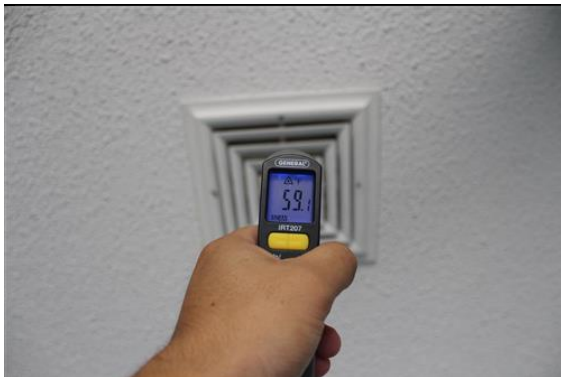
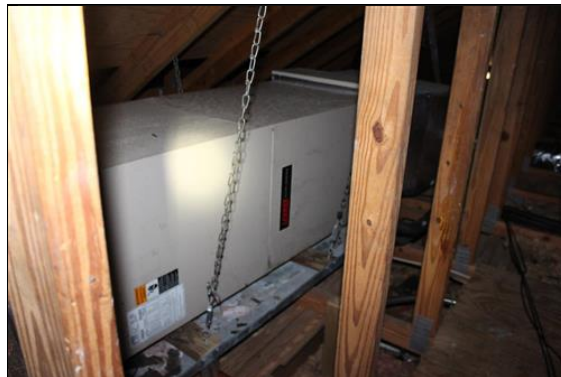
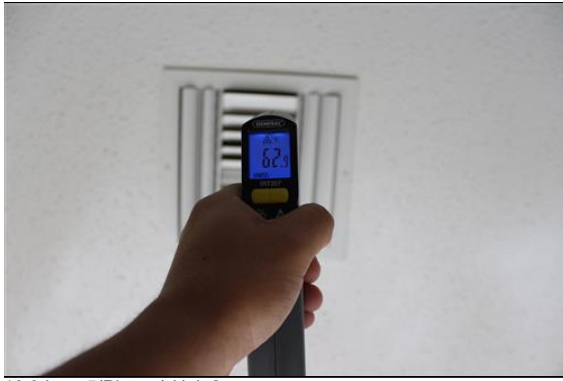
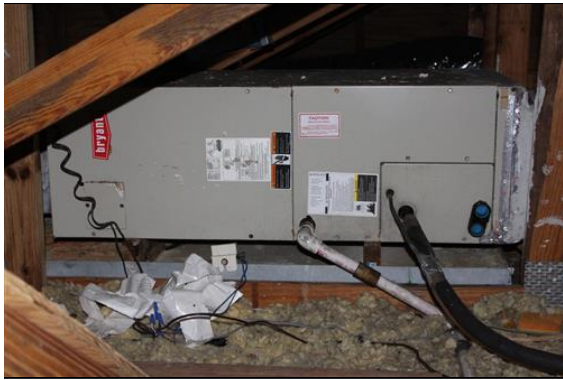
10.0 Item 1(Picture) Unit 2

The return air temperature was **62** degrees.

This indicates a difference of **13** degrees.

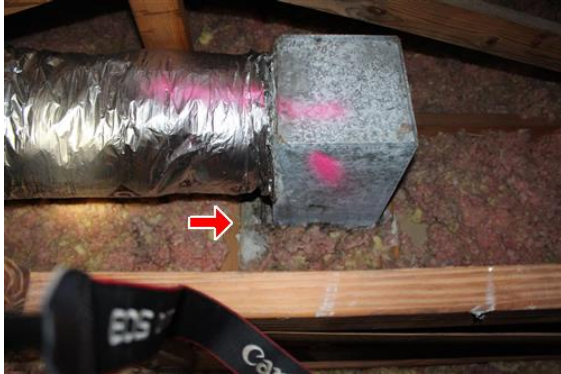
10.2 Item 1(Picture)

10.2 Some ducts in the attic are not properly seal. Repair is recommended.

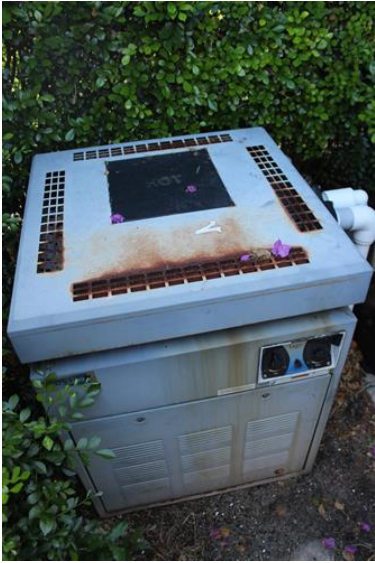
11.5 Item 1(Picture)

11.5 Pool Heater was disconnected.

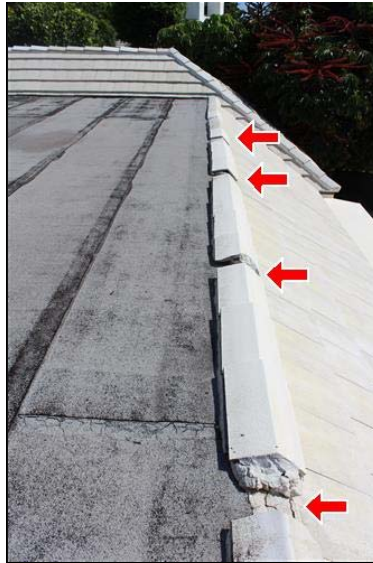
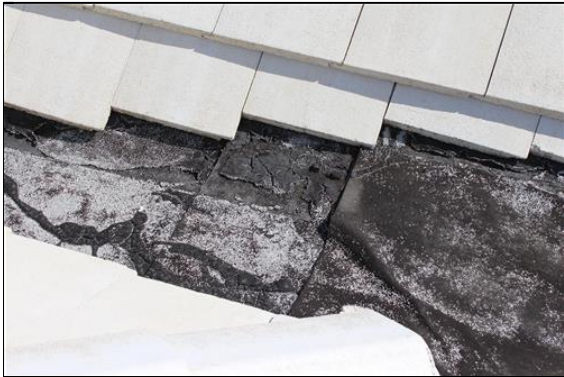
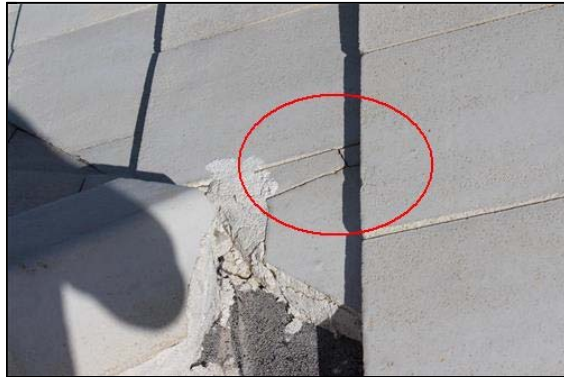
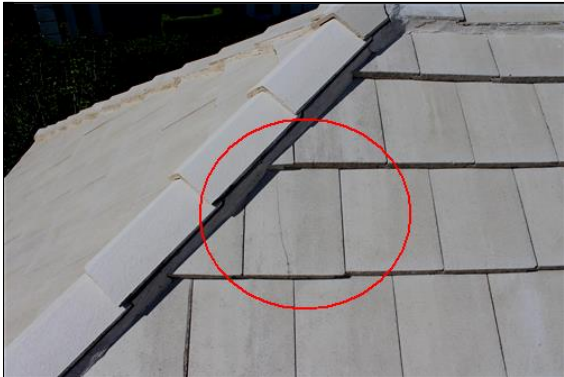
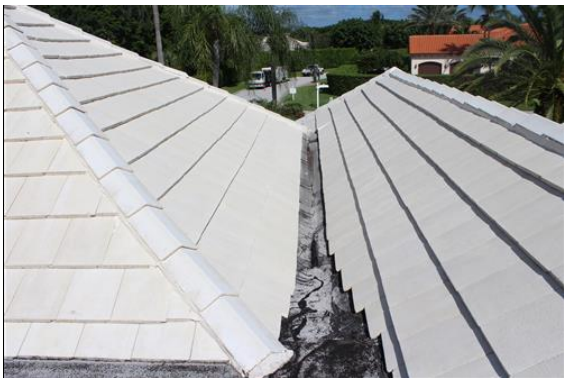
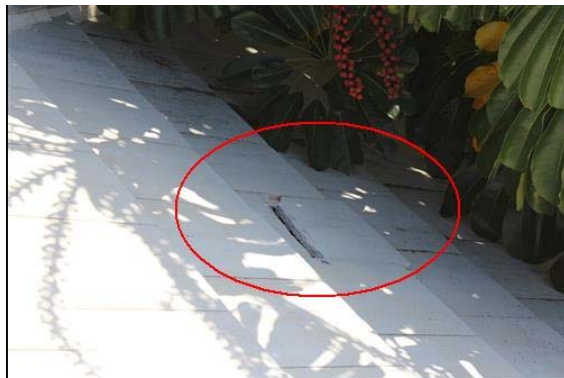
1.0 Item 2(Picture)

Multiple broken tiles, exposed nails, water ponding on flat part of the roof. Signs of water leaks on attic and inside the house. Dry at the time of the inspection. Further observation, evaluation, and repair by a licensed roofing contractor is needed.

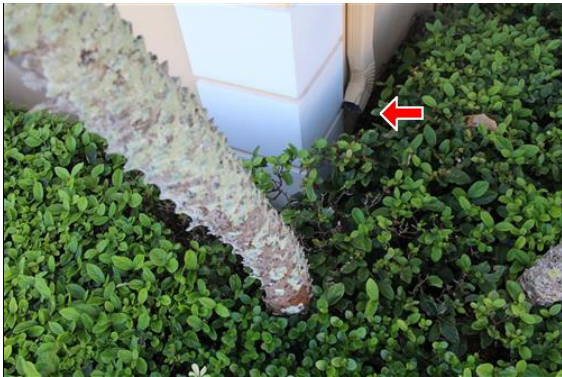
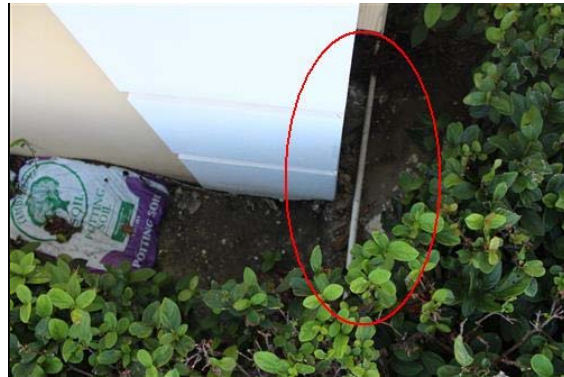
Installation of downspout extension is needed to avoid water erosion around pipe. Covering of pipe and downspout repair is recommended.

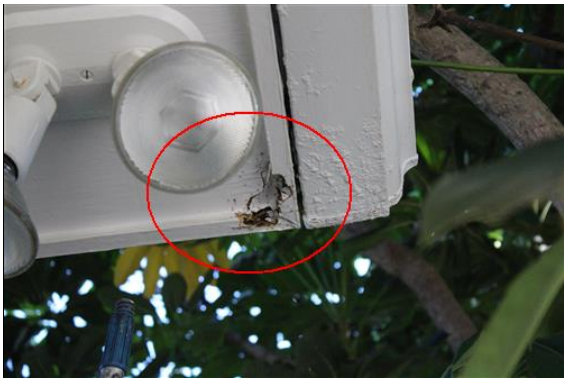
2.6 Item 1(Picture)

Rotted soffit in north east corner of the house. See attached Termite report. Repair is recommended.

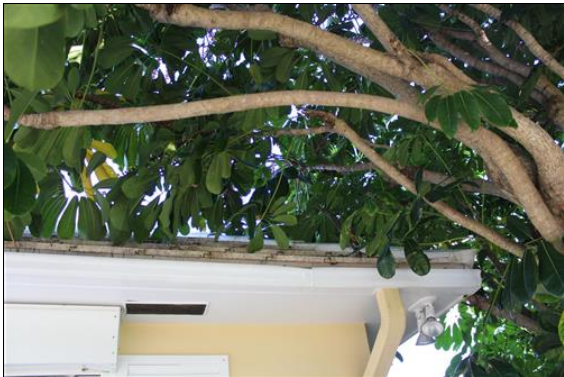
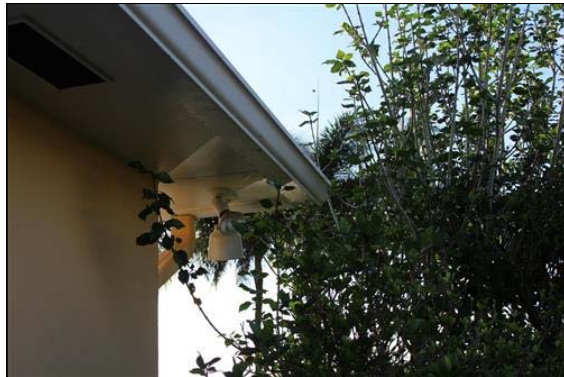
Trimming of trees at least three feet away from roof line is recommended.

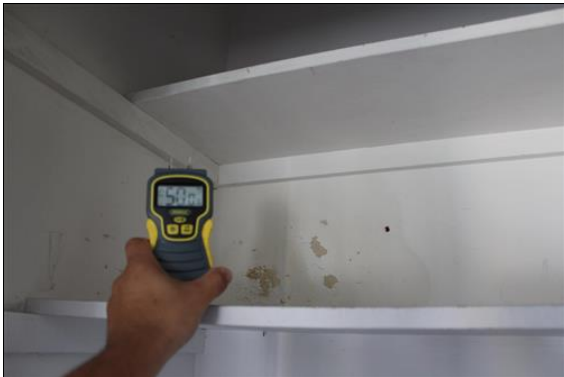
3.1 Item 1(Picture)

Wet drywall inside garage closet. There is broken tiles on roof in this area. Further Evaluation and repair by a general contractor is recommended.

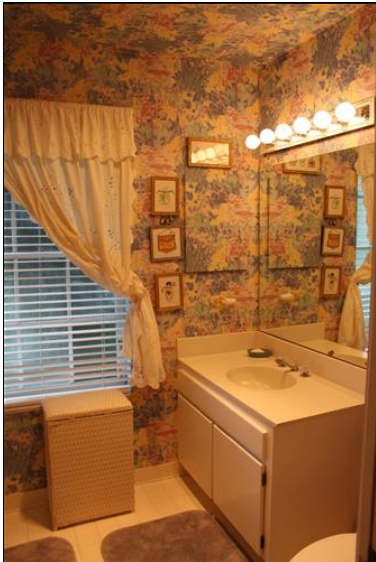
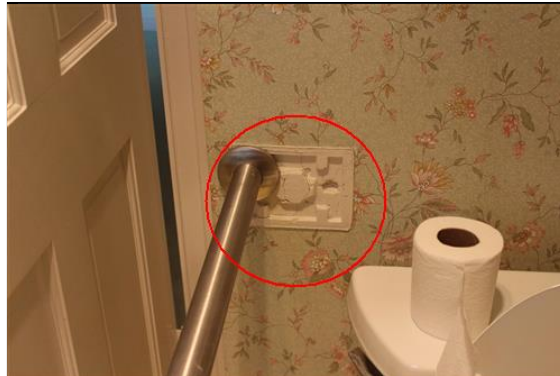
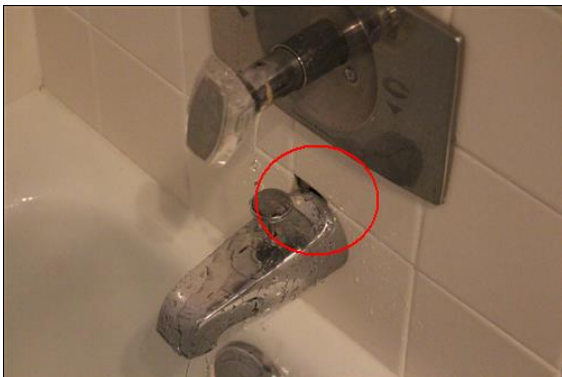
Repair of bathroom wall in the north side of the house is recommended. Sealing around diverter valve to prevent water intrusion on the wall is needed.

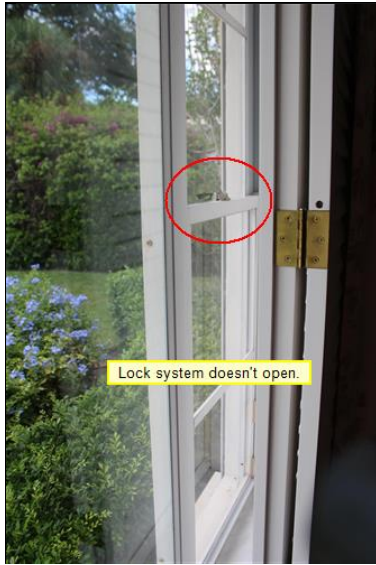
4.4.B Item 1(Picture)

Most windows were locked and could not be tested, but many of them have defective lock system and some of them will not stay open. Further evaluation and repair is recommended.

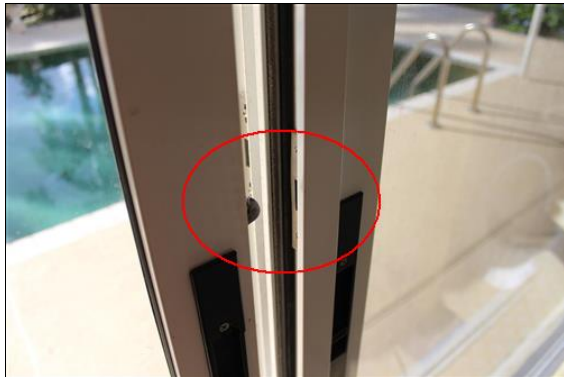
4.5.B Item 1(Picture)

Sliding door lock system is not working properly. Repair is recommended.

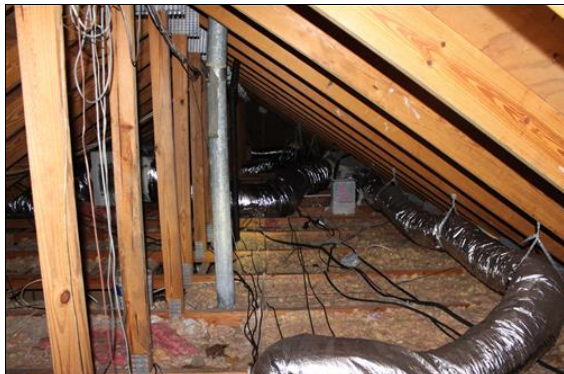
7.0 Item 1(Picture)

Existing blown insulation has less than 4" thickness. Repair by a licensed contractor is recommended

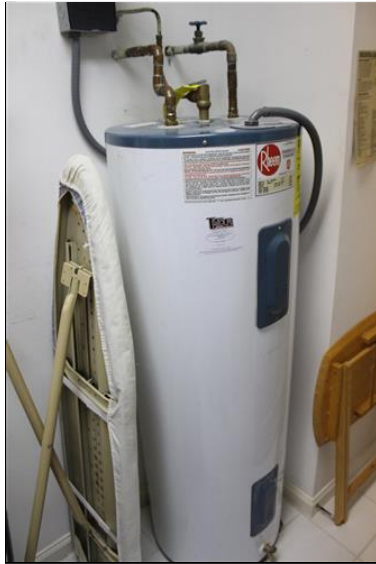
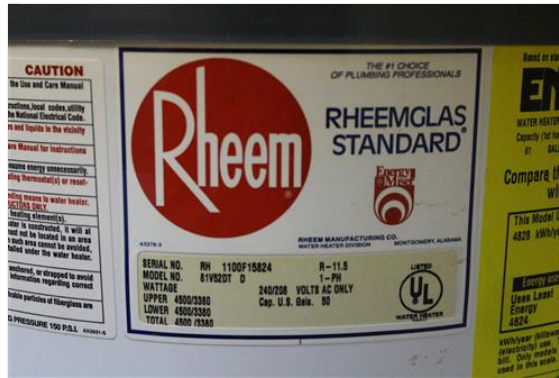
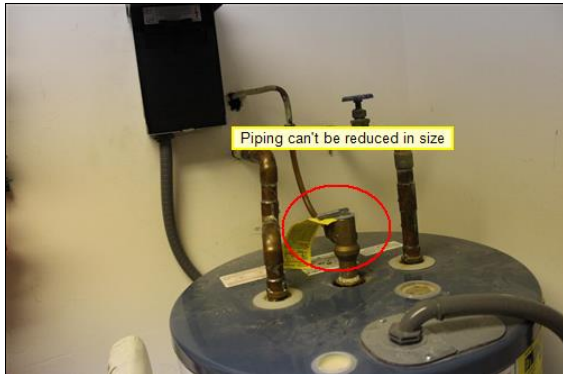
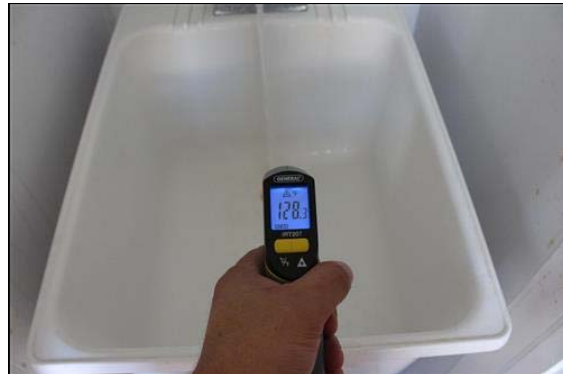
The T&P (Test and Pressure) valve on water heater needs a 3/4 threaded pipe to extend within 6 inches of floor for safety. I recommend repair by a licensed contractor.

This unit is working properly, but is at the end of its life expectancy and could require repair or replacement at anytime within the next five years.

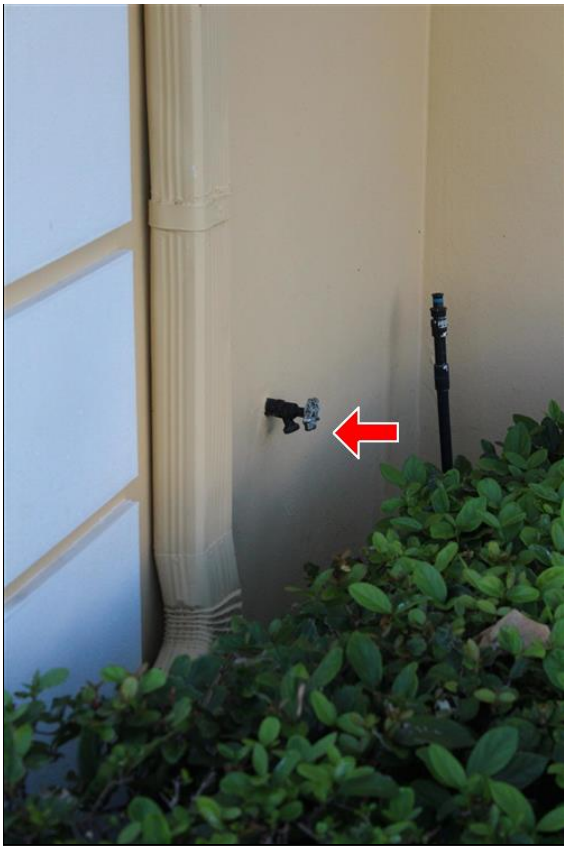
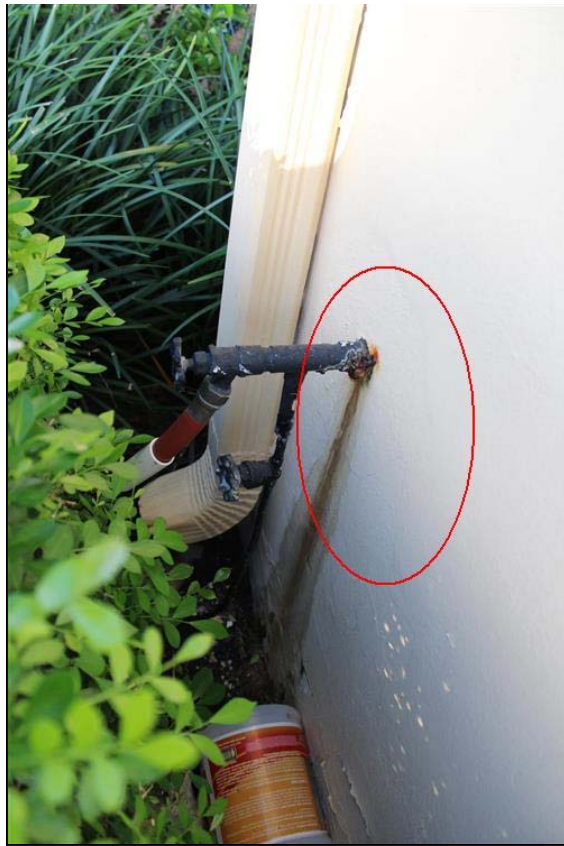
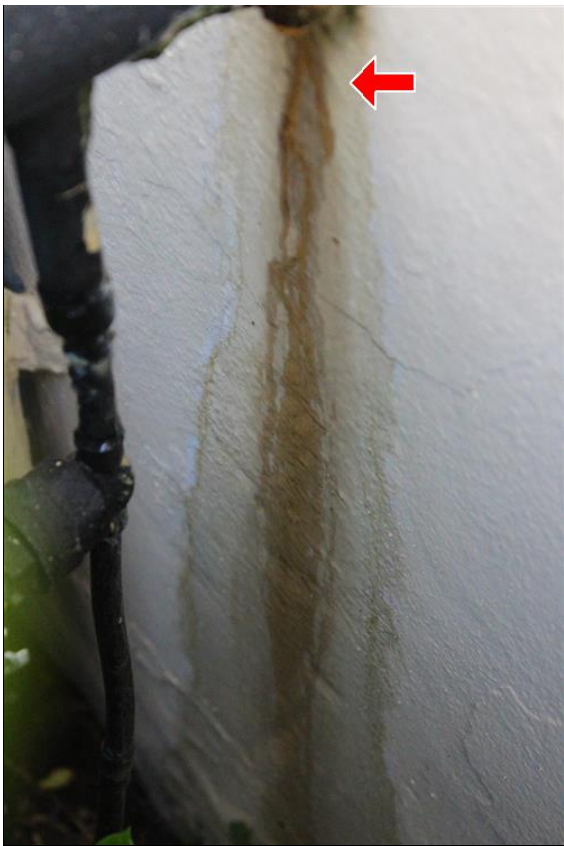
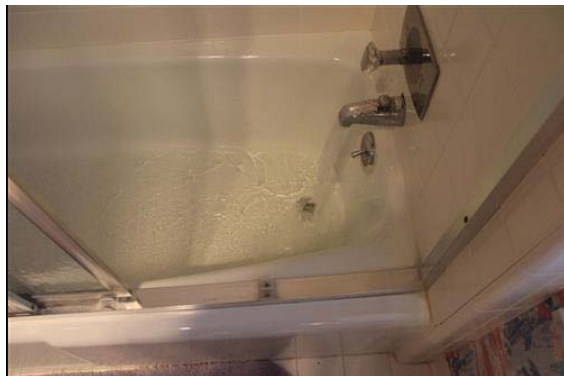
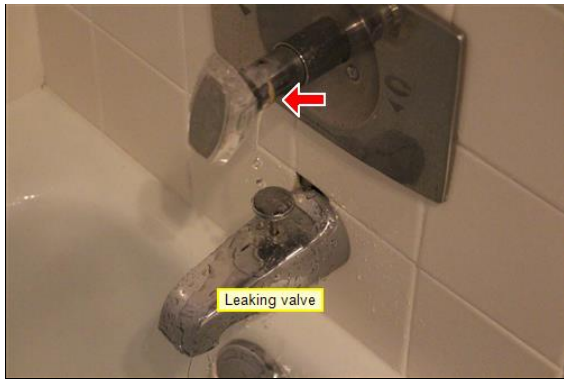
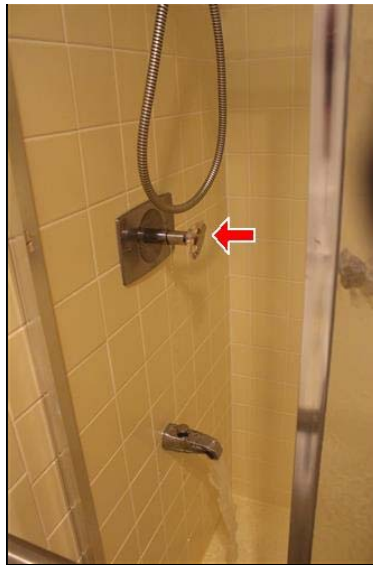
Installation of hose bib anti-siphon valve is recommended. Leaking exterior hose bib. Shower/tub valve is leaking. Further evaluation and repair by a licensed contractor is needed.

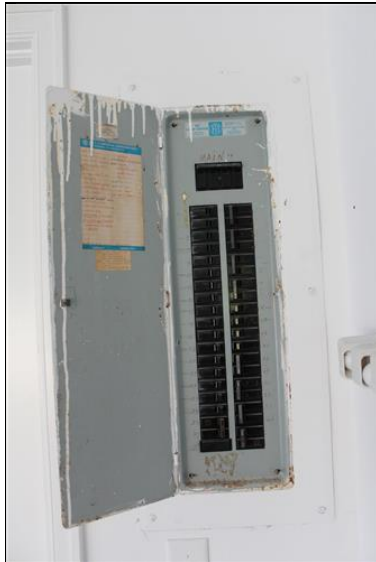
9.1 Item 1(Picture)

Double wiring present in a main panel circuit. Further revision and repair by a Licensed electrical contractor is recommended.

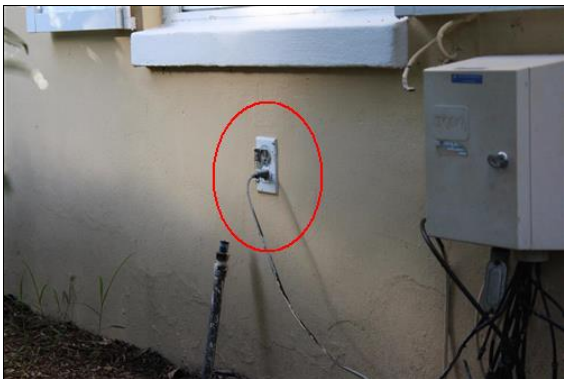
9.4 Item 1(Picture)

The outside outlet cover is damaged and needs repair or replace.

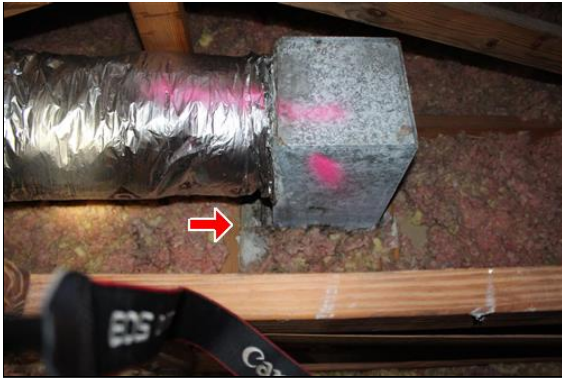
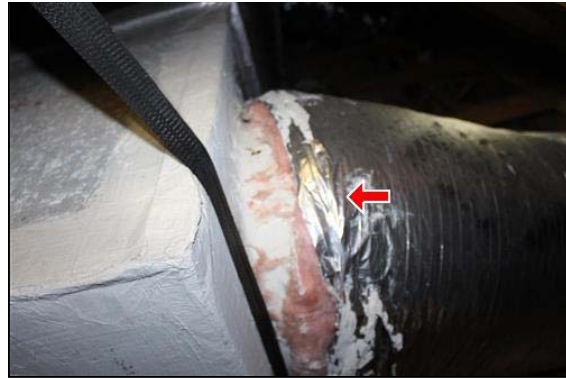
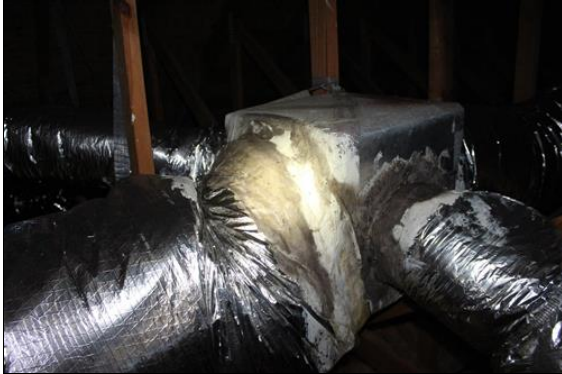
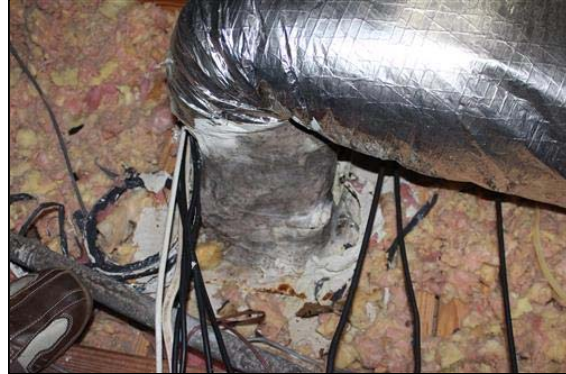
Some ducts in the attic are not properly seal. Repair is recommended.
